RenoNix PVD Magnet Profile

2020.09.03

PVD Magnet OPM NEW & Overhaul

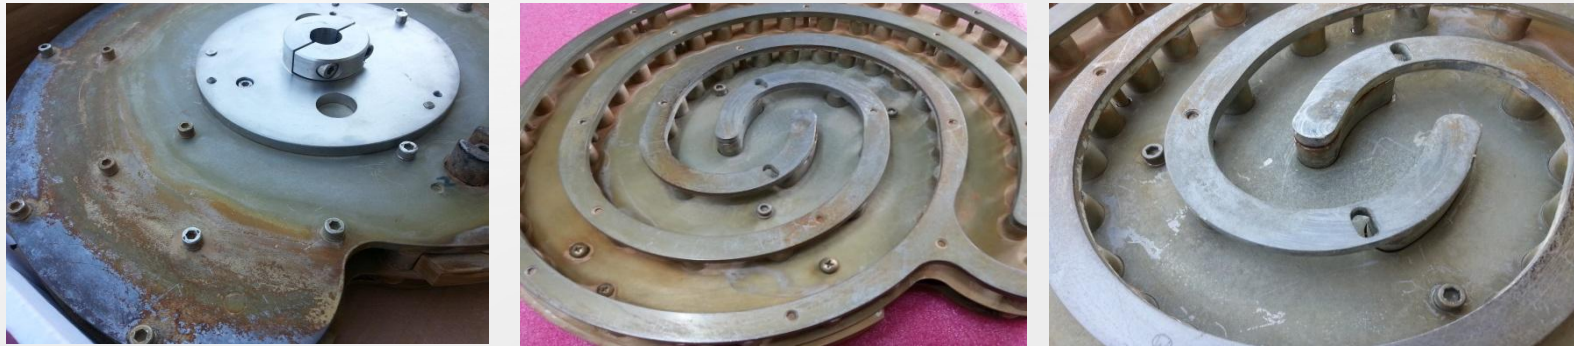
PVD Process issue caused by Magnet problem.

- ◆ Unstable uniformity after sputtering on Endura PVD
- ◆ Sputtering rate low by Magnet force low
- ◆ Irregular sputtering by unstable Magnet force
- ◆ Unstable DC Power by corroded Magnet
- ◆ Micro Arcing by corroded Magnet

Magnet is very important on Endura PVD Process. So User must be managed the Magnet force

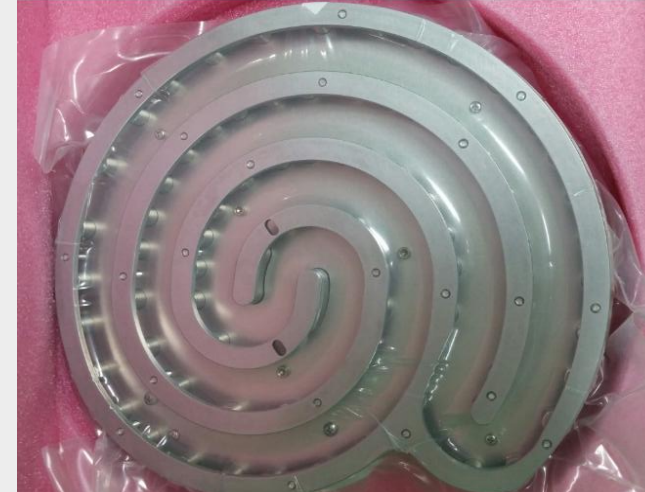
Magnet Assy Report

| 7. Check List | | | | |
|---|---|---|---|---|
| | Magnets 가측 검사 | 자력이 전방적으로 10% 정도 낮음 | | Center 부위는 자력이 현저하게 떨어짐(이동부) |
| Sensor Magnet | - | 부식 심하고 자력 떨어짐 | 센서 마그넷 교체 | 교체 필요 |
| Magnet Assy 부식도 | - | 전방적으로 부식도 매우 심함 | - | 외부 부식이 Center 부위까지 확산 |

1. NDT가이드 부식도록 부식이 상당함
 ** Magnet Assy 외곽과 중심 원소확인 자리로 부이 Center로 불려서 Magnet Chuck이 위로 올라 올림
 ** 불려 올린 Magnet Chuck이 자기 용출용 Target과 마그넷이 닿음 Magnet Chuck이 Scratches 발생됨
 ** Magnet Chuck과 Target의 마그넷을 일치시켜 Center 부이 고의 자력이 현저하게 떨어지는 현상이 됨
 2. 마그넷 위치가 정확하므로 10% 이상 낮아짐 (Center 부이 현저함)
 ** 전할 마그넷 교체 작업이 필요하며, 부식이 현저한 제품들은 Sensor Magnet 교체도 필요함
 3. 결함
 ** 전방적인 자력 교체 및 Magnet Chuck 교체 예정
 ** 부식된 부 제거용 환원도 이상의 세정 작업 예정
 ** 부식 혹은 부이 손 제거 용도 모두 교체 예정
 ** 본 제품은 Full Overhaul 대상 제품임
